BRAYTON CYCLE CAVITY RECEIVER DEVELOPMENT

QUARTERLY REPORT

JANUARY 1964 - MARCH 1964

(NASA Contract NAS 3-2779)

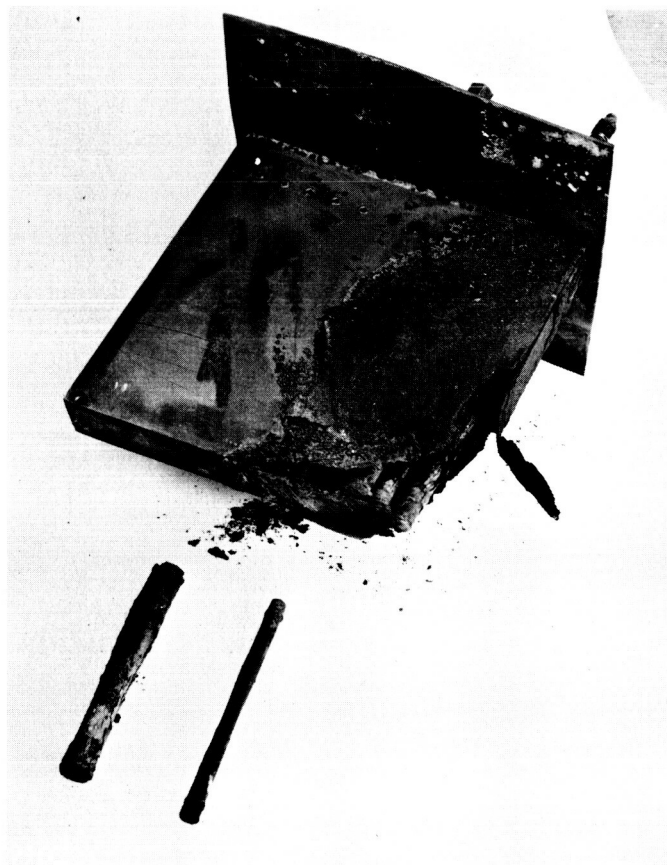
APPEARANCE OF CAPSULE CONTAINER WHICH FAILED AFTER
672 HOURS

Identification of the capsules which failed after 672 hours of operation was made by visual inspection. As shown in Figure 18, all three capsules were severely corroded. These capsules (No's 6, 7 and 8) were fabricated from 3/4 inch I. D. by 0.62 inch wall tubing with longitudinal seam welds. In view of the severity of attack incurred by the three capsules, a fourth Rene 41 capsule (No. 5), which did not fail, was also extracted for examination. This capsule was likewise fabricated from the 3/4 inch I. D. tubing. However, it did not contain the longitudinal seal weld. All four of the capsules were welded in the solution treated condition. Rene 41 was used as the filler material. The capsules were tested in the as-welded condition.

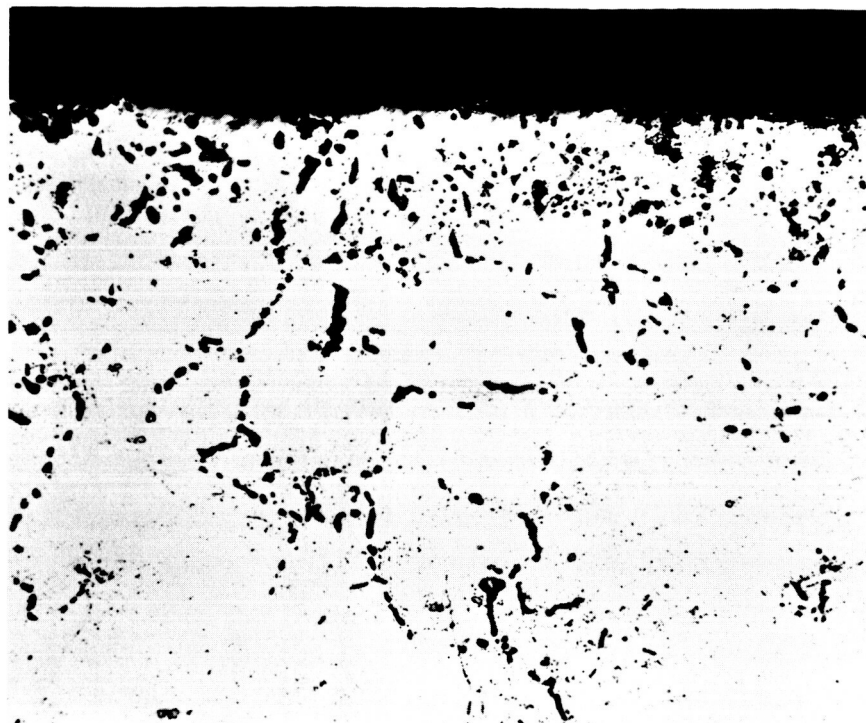
PHOTOMICROGRAPH OF SPECIMEN REMOVED FROM THE BOTTOM
OF RENE 41 CAPSULE NO. 8 SHOWING APPEARANCE AND SEVERITY
OF ATTACK. UNETCHED

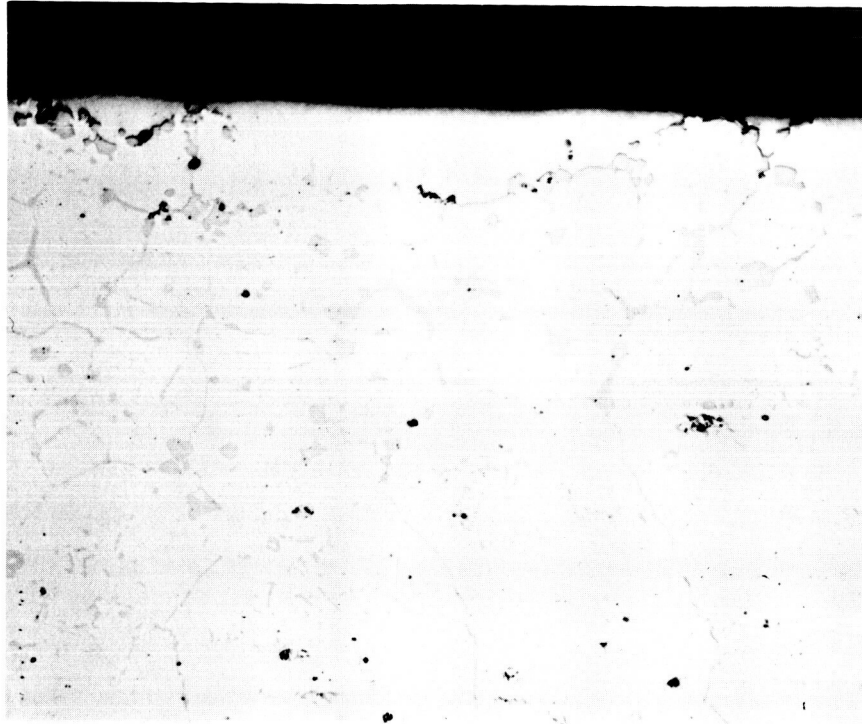
PHOTOMICROGRAPH OF SPECIMEN REMOVED FROM THE TOP
OF RENE 41 CAPSULE NO. 5 SHOWING THE GENERAL APPEARANCE
OF THE INSIDE SURFACE. UNETCHED.

Examination of the specimens removed from capsule no. 5, which did not fail revealed corrosive attack in the form of grain boundary penetration and leaching. The depth of attack varied along the inside surface from less than 0.001 inch at the top to 0.005 inch near the bottom of the capsule. Figures 20 and 21 illustrate the extremes of attack incurred. As shown in Figure 20, the penetration incurred was less than .001 inch. However, as can be seen, there appears to be a second phase present within the grain boundaries to a depth of 0.009 inch. As of the present time the significance of this apparent second phase is not known. A microprobe analysis is being made.

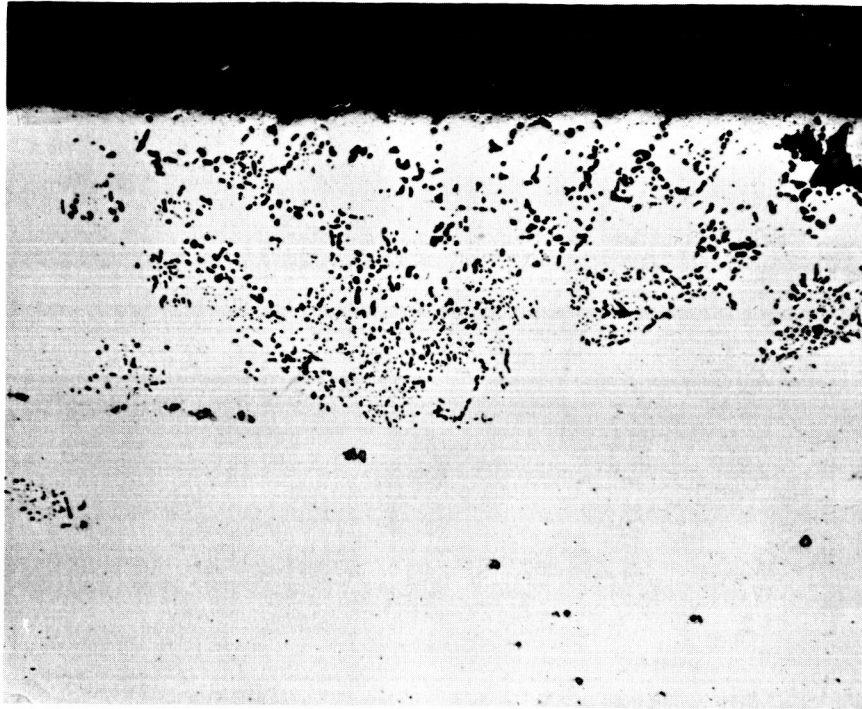
FIGURE 21

PHOTOMICROGRAPH OF SPECIMEN REMOVED FROM THE BOTTOM
OF RENE 41 CAPSULE NO. 5. SHOWING THE MAXIMUM AMOUNT OF
OF CORROSION INCURRED. UNETCHED

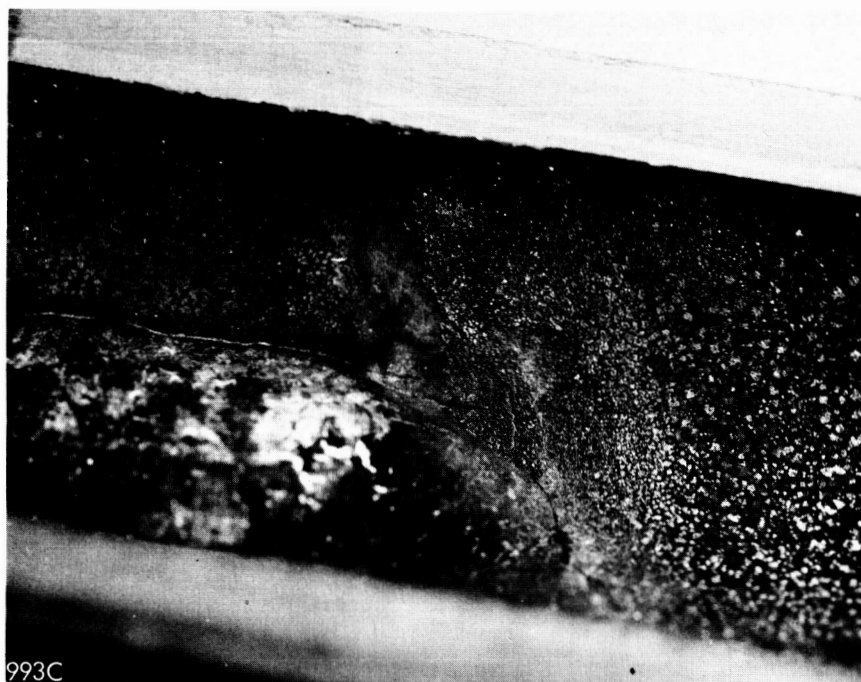
MACROGRAPH OF UDIMET 500 CAPSULE NO. 10 SHOWING THE CIRCUMFERENTIAL CRACK FOUND AT THE BOTTOM OF THE WELD BEAD. APPROXIMATELY 10 X (07686-1)

Likewise, when capsule no. 10 was opened, it was found to still contain LiF. However, it also contained a fluid. Examination of the inside tube surface revealed several circumferential cracks in the wall. The cracks were found at the base and at the top of the longitudinal seam weld. The crack of the base of the weld apparently occurred during the fabrication of the capsule since a leak in that area was found during the filling of the capsule. This crack was sealed by welding and building up the area with filler material. Examination of this area did not show any indications of the crack penetrating the build up. The crack at the top of the capsule apparently occurred during test. Evidently the liquid found when the capsule was opened entered the capsule through this crack. Before the capsule was opened, the capsule surface was immersed in an ammonium oxalate solution, water, and Stoddard solvent. The purpose of immersing the capsule in the various liquids was to remove traces of lithium fluoride and dye penetrant from the outside capsule surface. Figures 22 and 23 show the general appearance of the cracks.

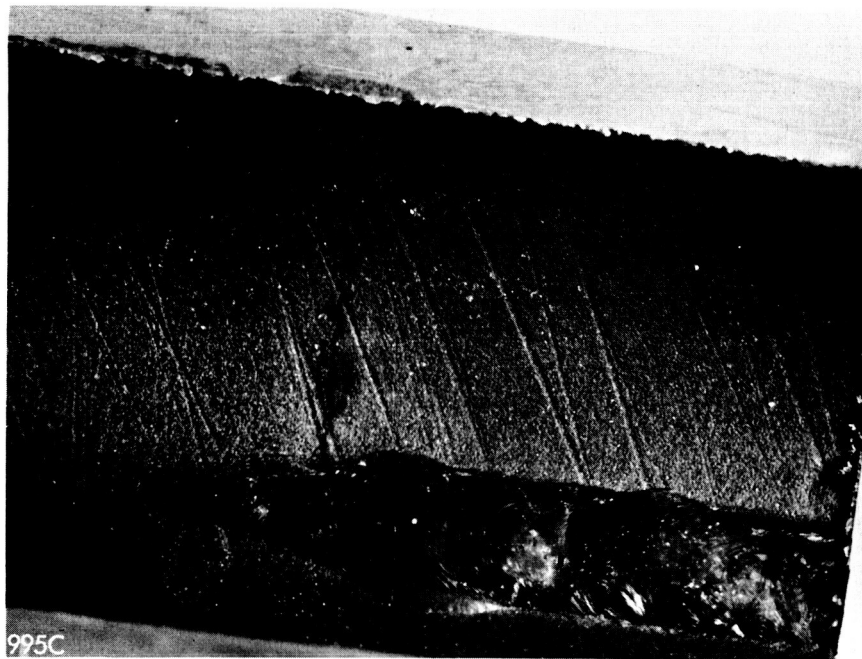
FIGURE 24

MACROGRAPH OF UDIMET 500 CAPSULE NO. 11 SHOWING
THE CIRCUMFERENTIAL CRACK FOUND AT THE TOP OF
THE WELD BEAD. APPROXIMATELY 10X (07686-2).

The two capsules, empty of LiF, were capsule no. 11 (Udimet 500) and capsule no. 18 (T. D. nickel). A circumferential crack was also found at the base of the weld in capsule no. 11. The crack is shown in Figure 24.

In general, the results found from metallographic examinations were the same as those reported for Capsule No. 10. However, only one crack, shown in Figure 24, was found in the tube wall. The condition of the tube wall around the crack was the same as reported for Capsule No. 10. The tube wall was completely penetrated. Away from the crack, leaching and intergranular penetration was found to a maximum depth of .003 inch.

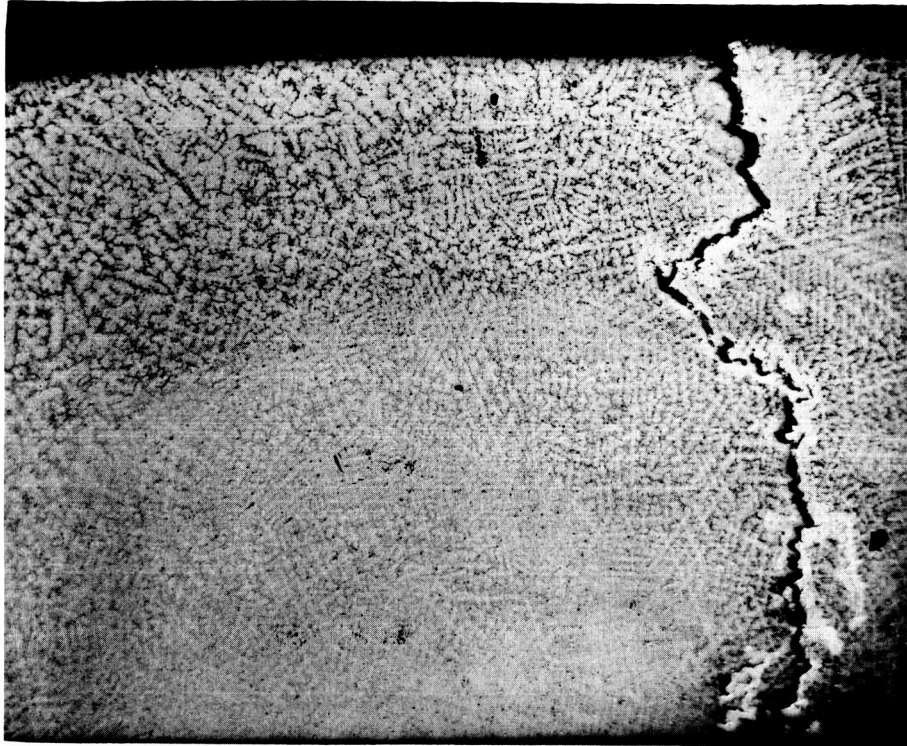
FIGURE 25

PHOTOMICROGRAPH OF UDIMET 500 CAPSULE NO. 10 TUBE
WALL SHOWING THE ATTACK INCURRED ON THE CRACK
SURFACE. REFRACTORY METALS ETCH.

Metallographic examination of specimens removed at each crack revealed that both cracks had completely penetrated the tube wall. Also, as shown in Figure 25, around the cracks, attack in the form of leaching and intergranular penetration was found. The attack had completely penetrated the tube wall. Metallographic specimens removed from the same location, but from the opposite side of the tube where the crack was found also revealed a leaching and intergranular attack. However, as shown in Figure 26, the attack was limited to depths between .002 to .004 inches.

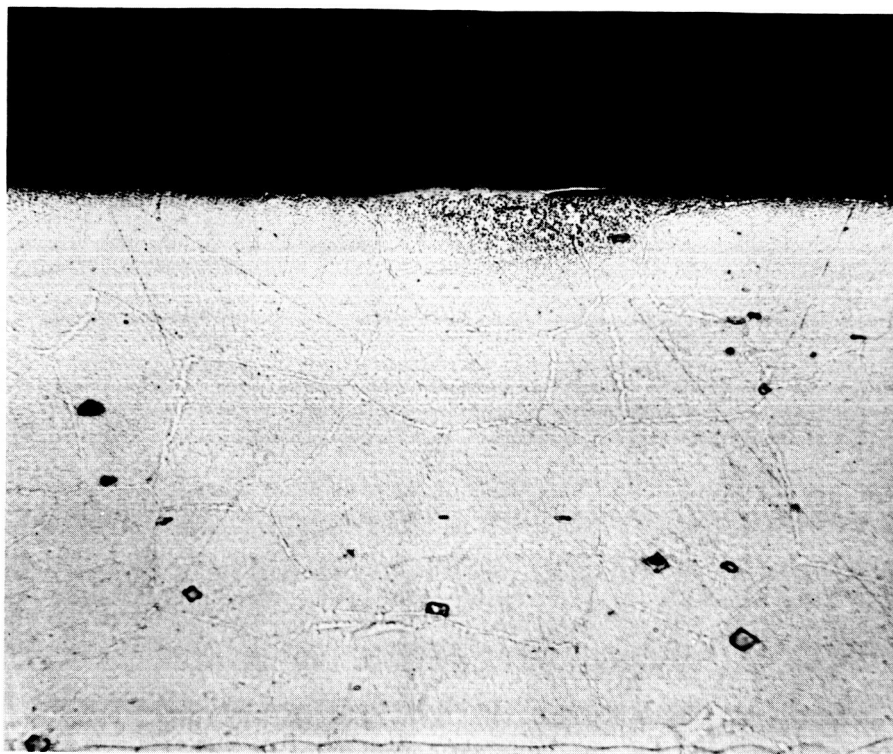
PHOTOMICROGRAPH OF THE INSIDE SURFACE OF UDIMET 500
CAPSULE NO. 10 SHOWING THE MAXIMUM DEPTH OF ATTACK
INCURRED 100° AWAY FROM THE CRACK. REFRACTORY
METALS ETCH.

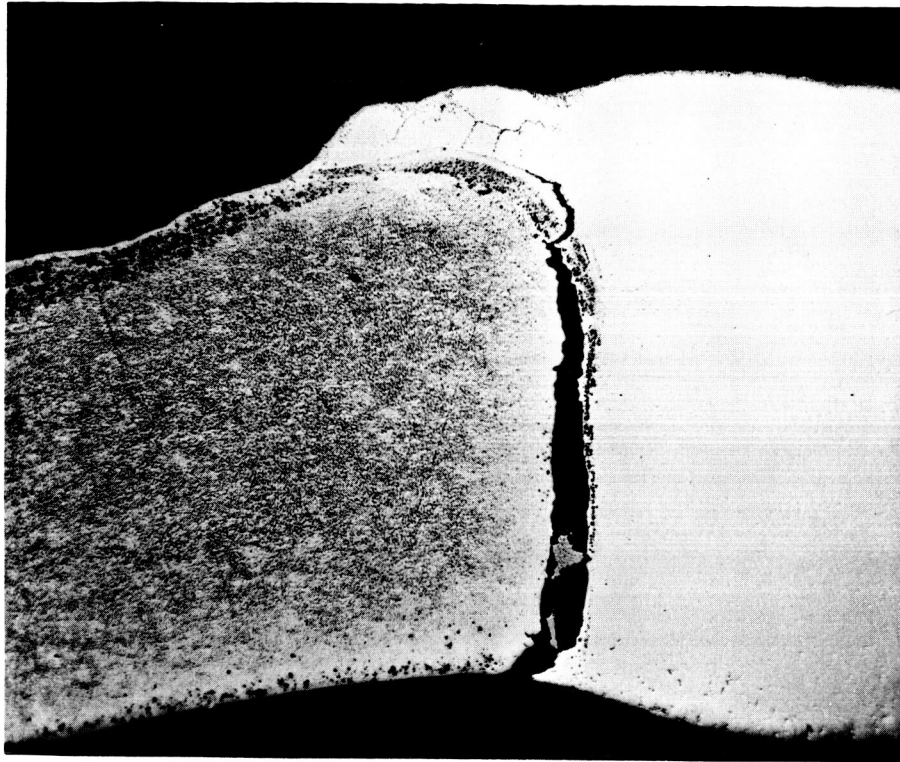
PHOTOMICROGRAPH OF THE WELD BEAD IN TD NICKEL CAPSULE
NO. 18 SHOWING THE APPEARANCE OF THE CRACK AND CORROSION.
CARAPELLAS ETCH.

As shown in Figure 27 a crack was found which penetrated the weld bead at the top of the capsule. Around the weld bead, attack in the form of intergranular penetration and leaching was found. The maximum depth of attack incurred was 0.004 inch. Examination of the TD nickel tube wall revealed a small amount of attack. Sections from both above and below the liquid level revealed a solution type of attack. The maximum depth found was less than .001 inch.

Although the extent of attack incurred in TD nickel Capsule No. 18 was less than that found in the Udimet 500 Capsules, the results obtained from the examination lead to the same conclusion. That is the failure occurred through mechanical means.
